**Professional Analysis
and Consulting, Inc.**

Project No. 2018

**SIG SAUER, INC. AND CITY
OF CAMBRIDGE**

Date of Report: November 29, 2023

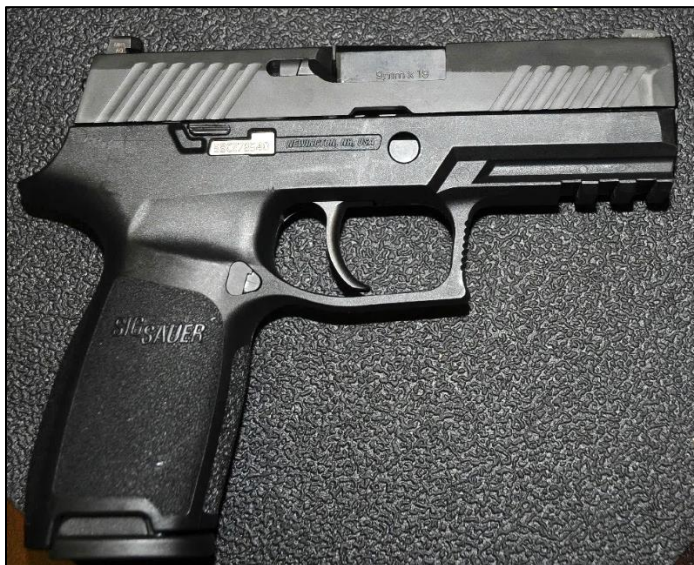
Figure 2 - Subject Sig Sauer P320

Examination of CPD Lt. Ahern's pistol found several manufacturing defects, consistent with several previous P320 firearms inspected, which fired un-commanded (no trigger pull by the user) under similar circumstances. These defects explain and support Lt. Ahern's report of an un-commanded discharge of the firearm. The following items were identified:
